MEMORANDUM

TO: City of Tucker

FROM: VHB and Gresham Smith

SUBJECT: PEDESTRIAN CROSSING IMPROVEMENTS
FIELD OBSERVATIONS AND RECOMMENDATIONS

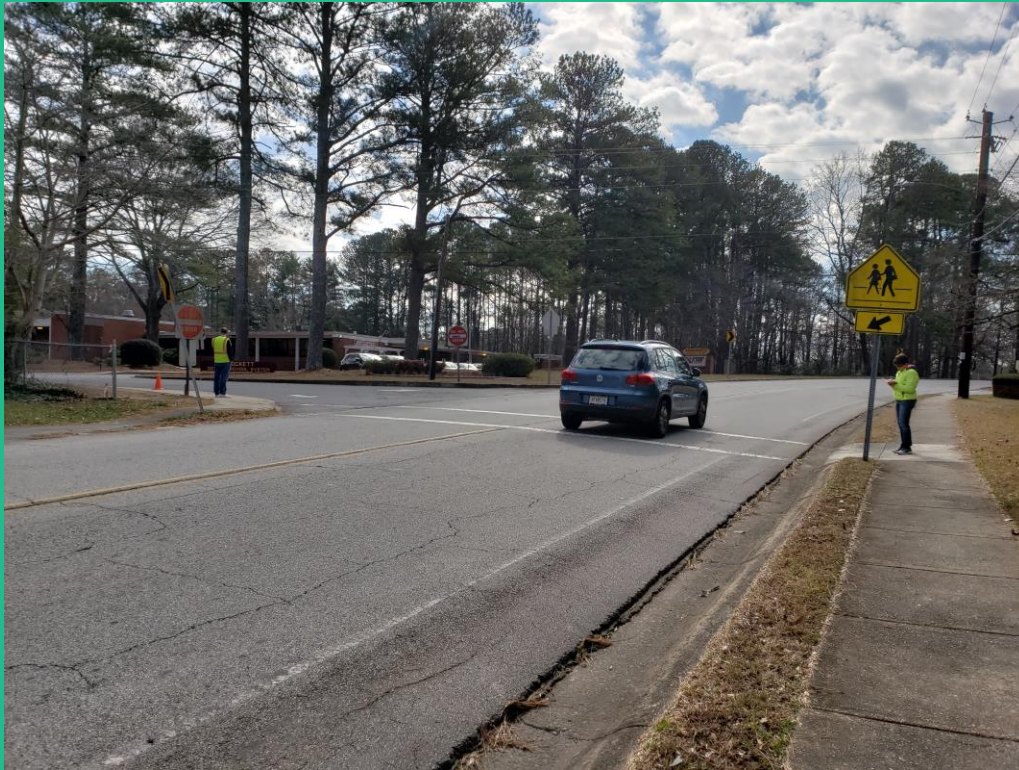
The portion of Brockett Road of interest for this task is adjacent to Brockett Elementary School. The speed limit along Brockett Road is 40 MPH with a school zone speed limit of 25 MPH. The two active school zone periods are from 7:15 to 8:15 AM and 1:45 to 2:45 PM for morning drop-off and afternoon pick-up, respectively. The school is located along a curve on a two-lane roadway and contains two driveways – a one-way entrance and a one-way exit onto Brockett Road. The northern driveway includes a marked crosswalk that consists of two simple striped lines. There is limited sight distance for vehicles exiting the driveway onto Brockett Road, which may make turning difficult and pose a safety challenge. The southern driveway contains only school crossing signage and no marked crosswalks. School zone signage at this location is worn and faded. Sidewalks exist on both sides of the road, except along school property. These factors make this a viable location for a mid-block crossing.

Figure 5: View of Brockett Elementary School and crossing lines in pavement looking southbound

- Install high-visibility marked crosswalks with flashing beacons.
- Install advanced signage on both ends of the school, prior to the crossing locations.

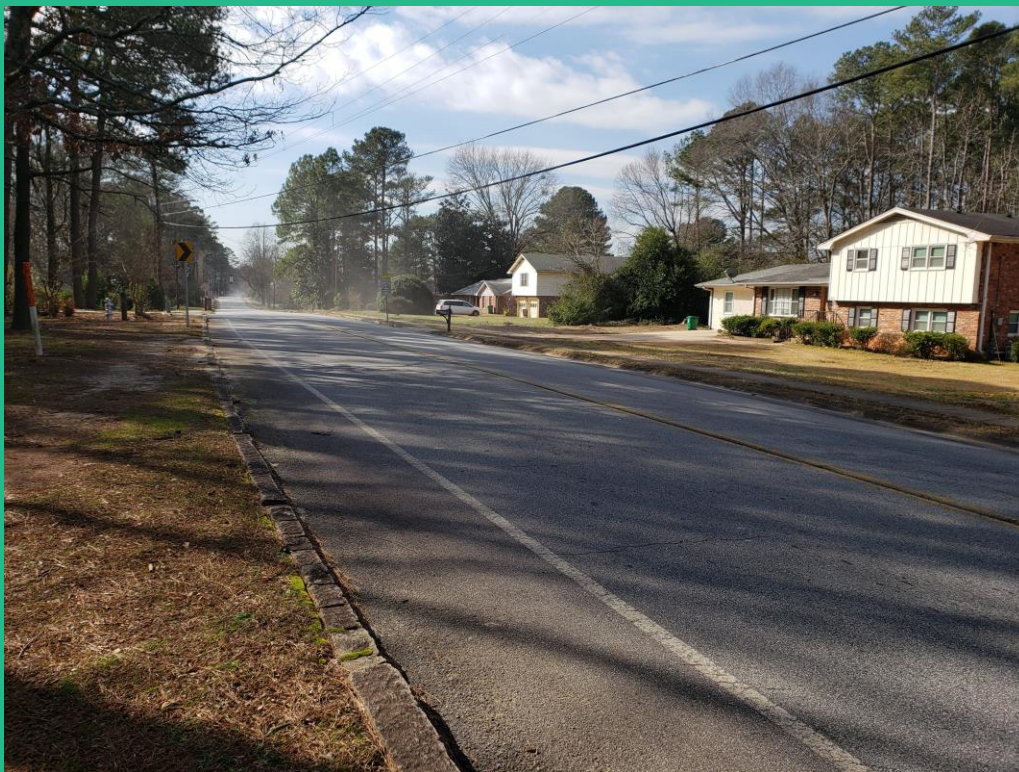
Figure 6: View of desire path in front of school and sidewalk on opposite side of the road

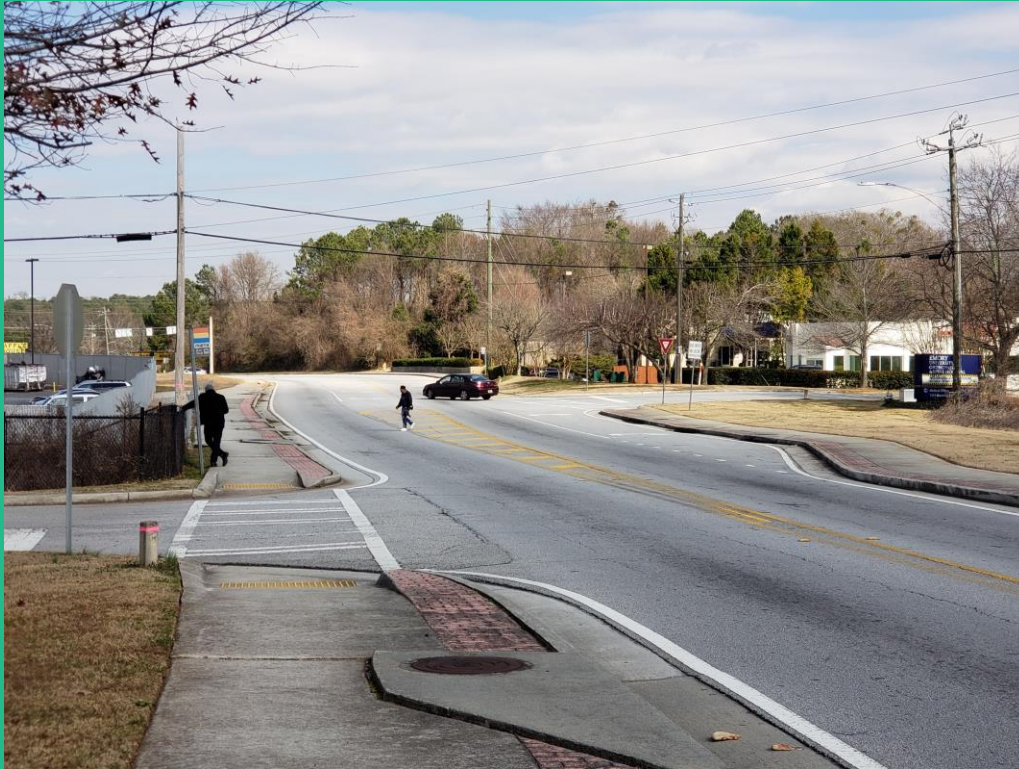
get off the bus northbound stop. At the southbound stop, 15 people get on while two people get off the bus. In this segment of Montreal Road, sidewalks exist on both sides of the road, and there are two travel lanes (one in each direction) and a center turn lane. During the field visit, the consultant team observed multiple pedestrians crossing the road, walking along the sidewalk, and waiting for the bus.

Figure 7: Pedestrian crossing Montreal Road in front of Emory Clinic while another pedestrian waiting at MARTA bus stop observes

- Install a mid-block crossing just south of Woodlawn Circle. The crossing would include a crosswalk with a zig-zag alignment across Montreal Road, and a concrete pedestrian refuge island in the center to facilitate a two-phase crossing.

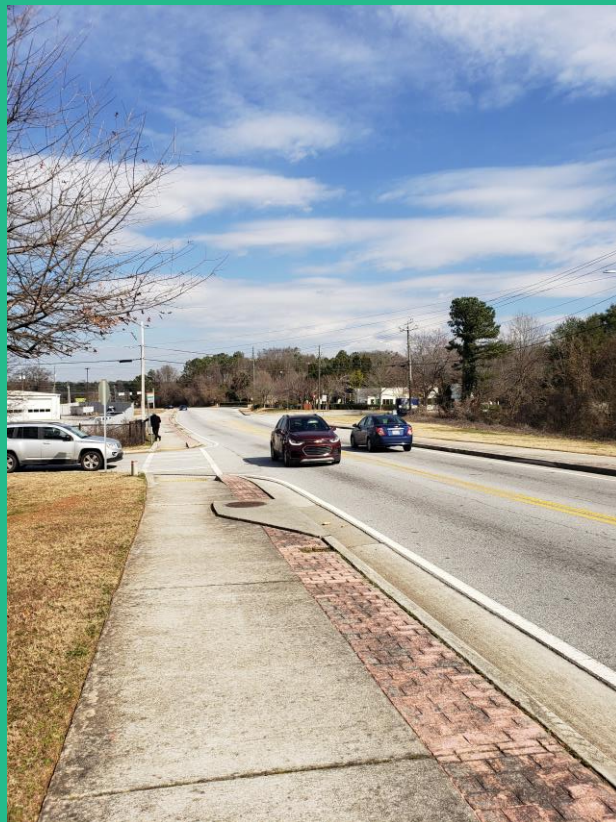
Figure 8: Cars passing down Montreal Road looking north towards Lawrenceville Hwy/US 29

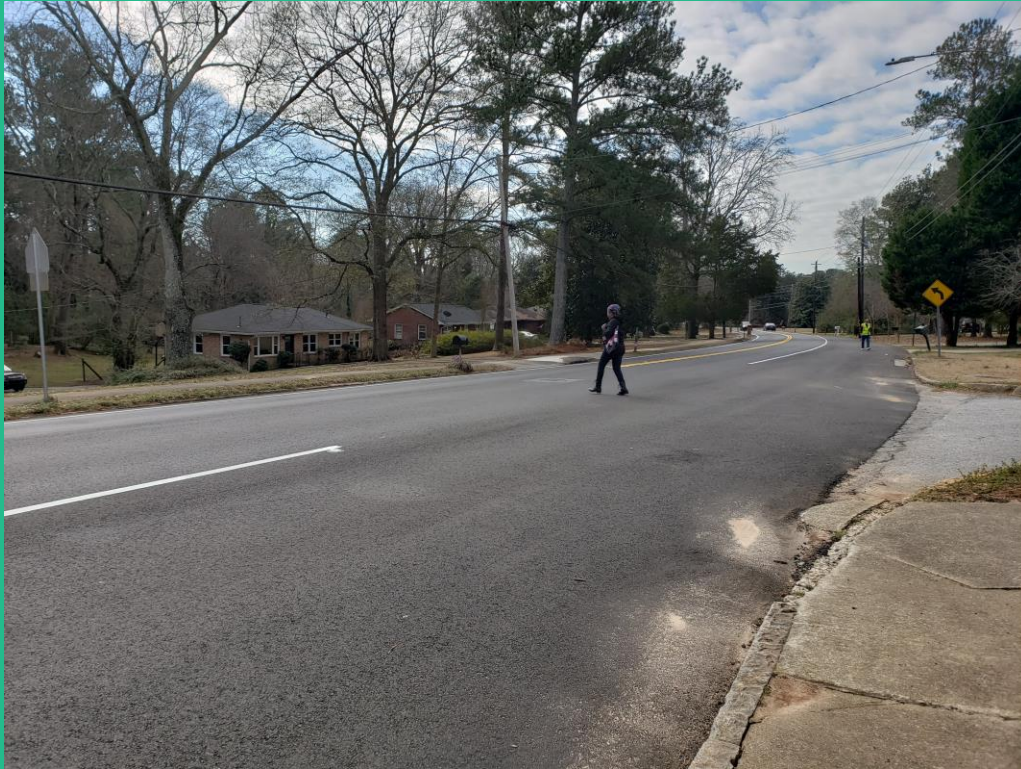
however, there were markings indicating that these are to be restriped in the near future. A “Reserved for Crossing Guard” sign is located at the southern school driveway. A walkway is present from the school entrance located in the middle of the school, between the two school driveways, likely to connect people entering and exiting the school building with the crosswalk. A continuous sidewalk exists on the east side of the road, while a sidewalk on the west side of the road is only in front of the school. There are missing curb ramps and drainage issues along the sidewalk in front of the school, near the southern driveway. The project team considers this a viable location for crossing improvements.

Figure 9: View southward and of pedestrian crossing Idlewood Road in front of school's exit-only driveway

- Crossing improvements should be strongly considered at the school's southern driveway, or the one-way exit.
- Install a bump-out to improve visibility.
- Make appropriate drainage improvements.
- Install advanced signage on both ends of the school, prior to the crossing locations.
- Consider installing a structure to help convey stormwater in the event of heavy rainfall.

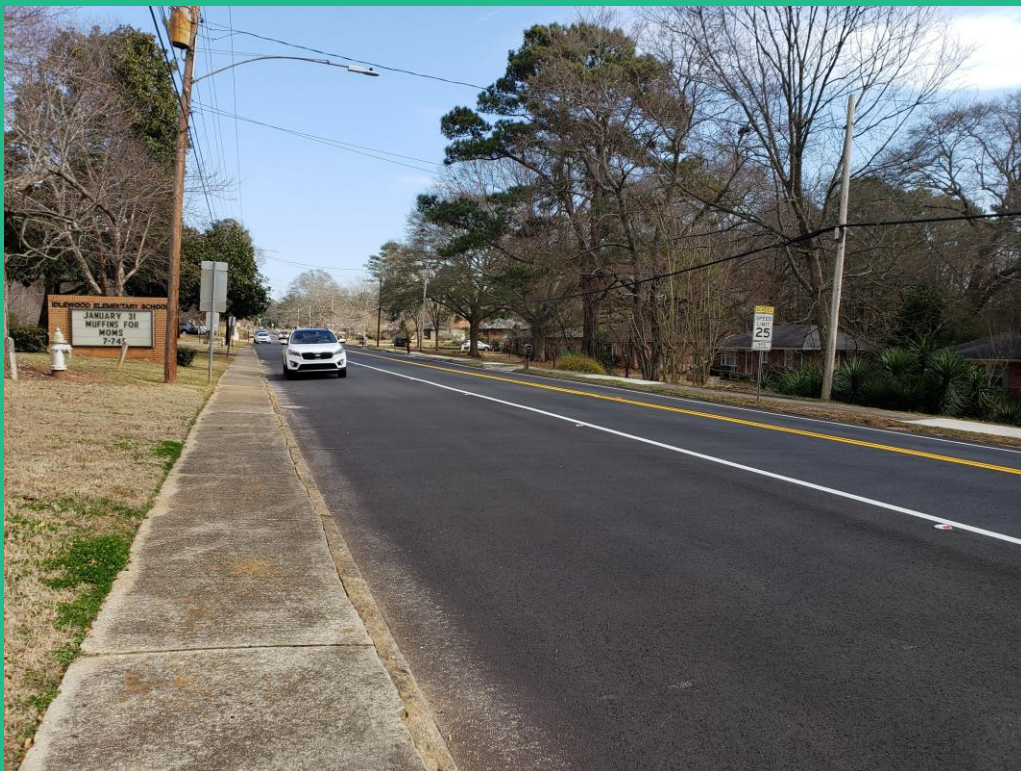
Figure 10: View northward with Idlewood Elementary School to the left; also includes freshly paved Idlewood Road

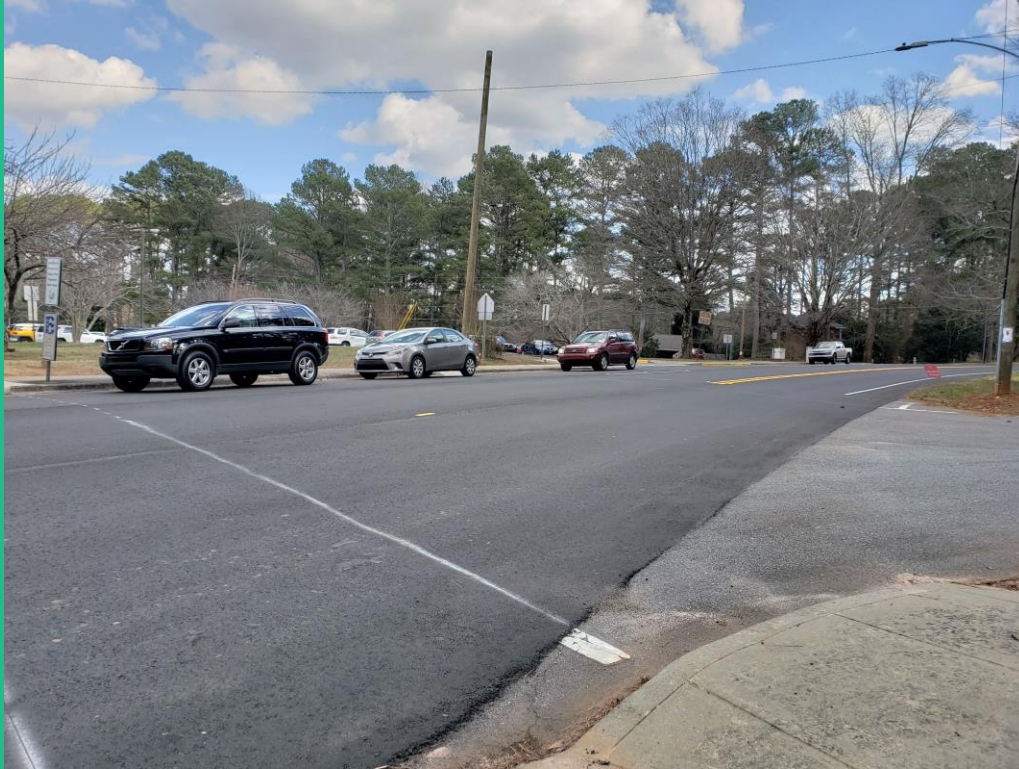
Midvale Elementary School along Midvale Road is located between two curves in the road that present sight distance issues from both ends of the corridor. The speed limit along this stretch of Midvale Road is 35 MPH with a school zone speed limit of 25 MPH. School zone signage exists on either end of the school zone and two "Pedestrian Crossing Ahead" signs are located at Midvale Circle in front of the school and at Midvale Court west of the school. Two sets of existing crosswalks were in the process of being restriped during the field visit, including:

Figure 11: A line of cars in front of crosswalk at Midvale Elementary School that, at the time of the field visit, was not yet painted after the resurfacing of Midvale Road near Midvale Circle

- Consolidate the two crossings directly in front of the school at Midvale Circle.
- Install advanced signage prior to the crossing location.

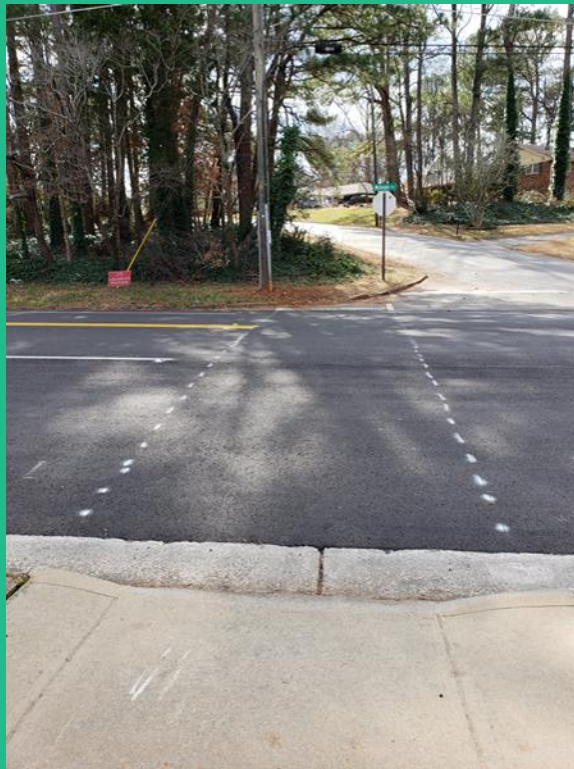
Figure 12: View of a crosswalk from Midvale Elementary School

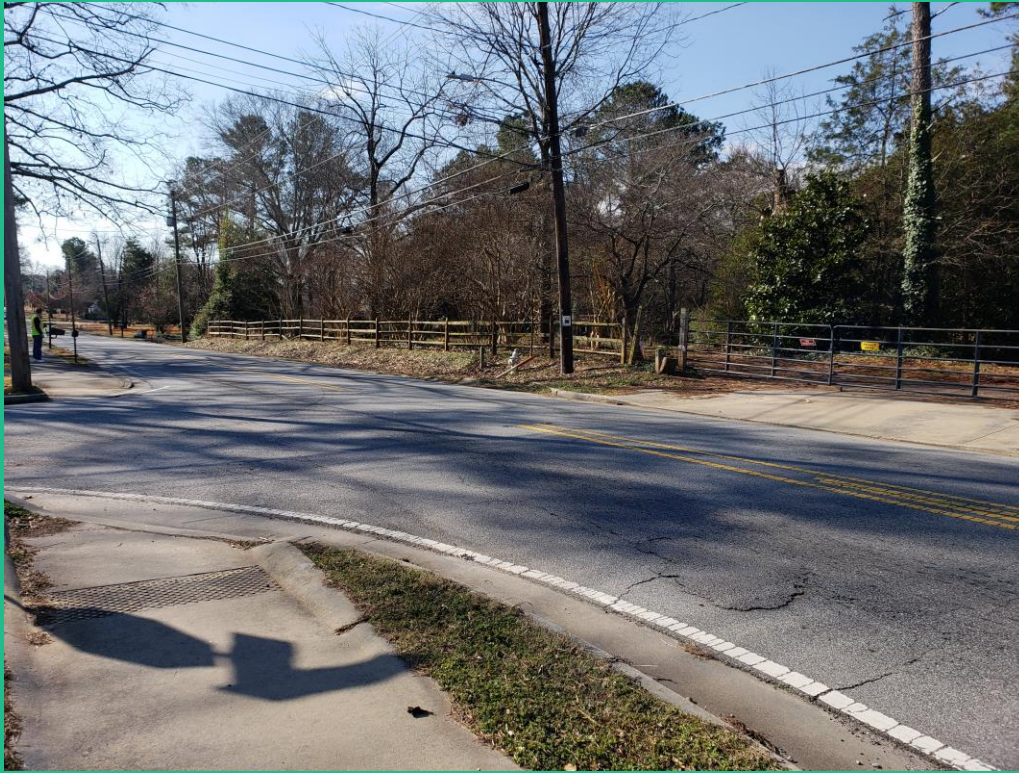
The intersection with Elmdale Drive is located just south of the signalized intersection with Fellowship Road. The posted speed limit in this area is 35 MPH, and there are two MARTA bus stops (one each direction) near Elmdale Drive. There are no sidewalks on the west side of Idlewood Road south of this intersection, and there are no crosswalks across Elmdale Drive. Sidewalks along this portion of Idlewood Road are recommended as a long-term project in the draft Tucker STMP. The proximity to the signalized intersection at Fellowship Road and low-density, single-family homes in the area might make this seem like an unlikely location for a mid-block crossing placement; however, a substantial number of people get on and off buses at this location. This may be due to the presence of a nearby apartment complex. Approximately 12 people get off the bus at the northbound Elmdale Drive stop and 15 people get on at the southbound stop. This level of activity at these bus stops points to a need for a mid-block crossing at Elmdale Drive.

Figure 13: View of Idlewood looking south from sidewalk at Elmdale Drive intersection

- Install curb cut ramps and a painted mid-block crossing north of the intersection.
- Install rectangular rapid flashing beacons (RRFB) at the crosswalk.
- Install advanced signage prior to the crossing location.

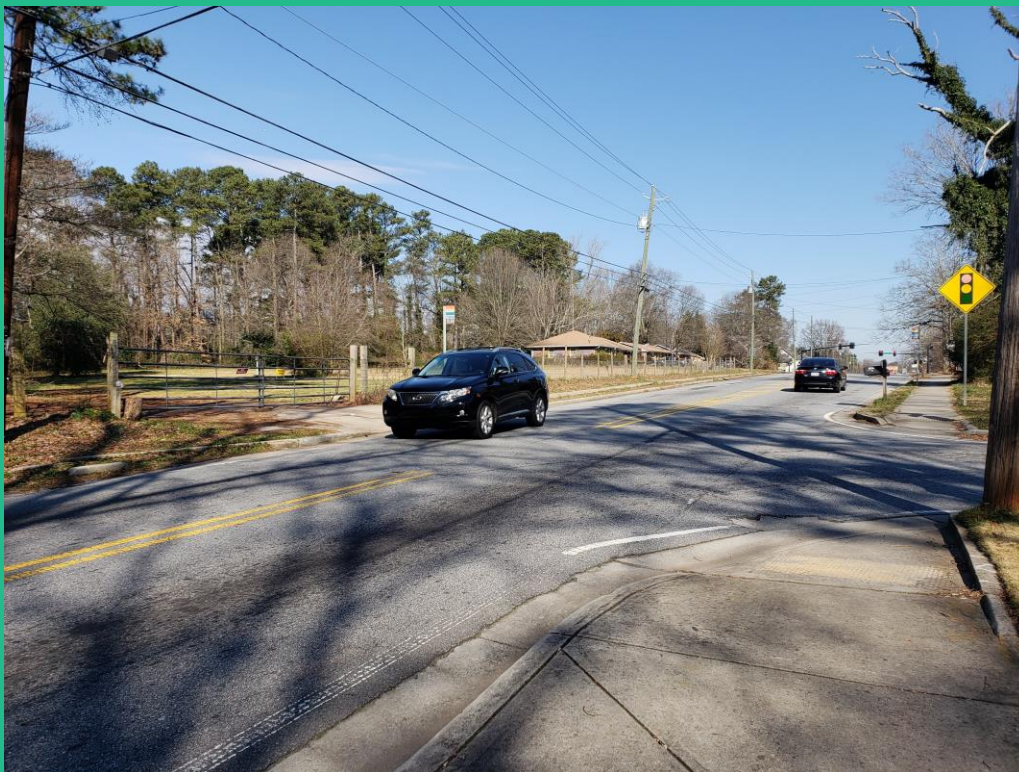
Figure 14: View of existing MARTA bus stop looking north towards Fellowship Road intersection

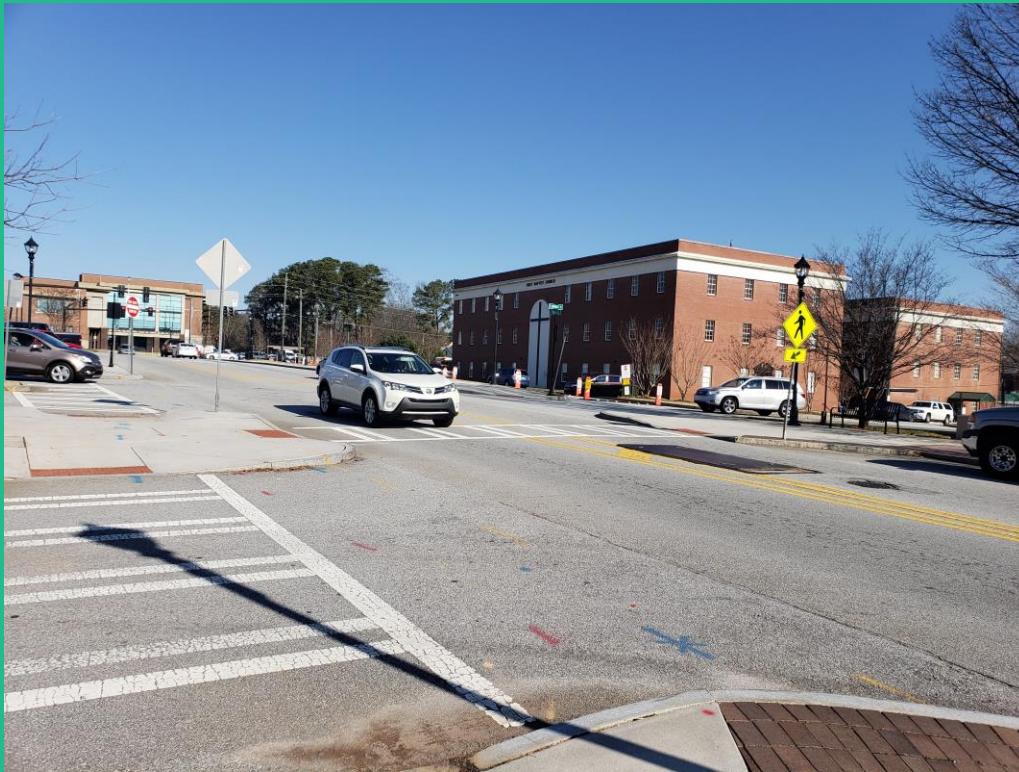
Figure 15: Existing crosswalk at Lynburn Drive intersection can be upgraded to improve safety

- Refresh existing pavement markings.
- Install supplemental signage with flashing lights.
- Consider rectangular rapid flashing beacons (RRFB).
- Add an in-street pedestrian crossing sign at the crossing at Lynburn Drive.

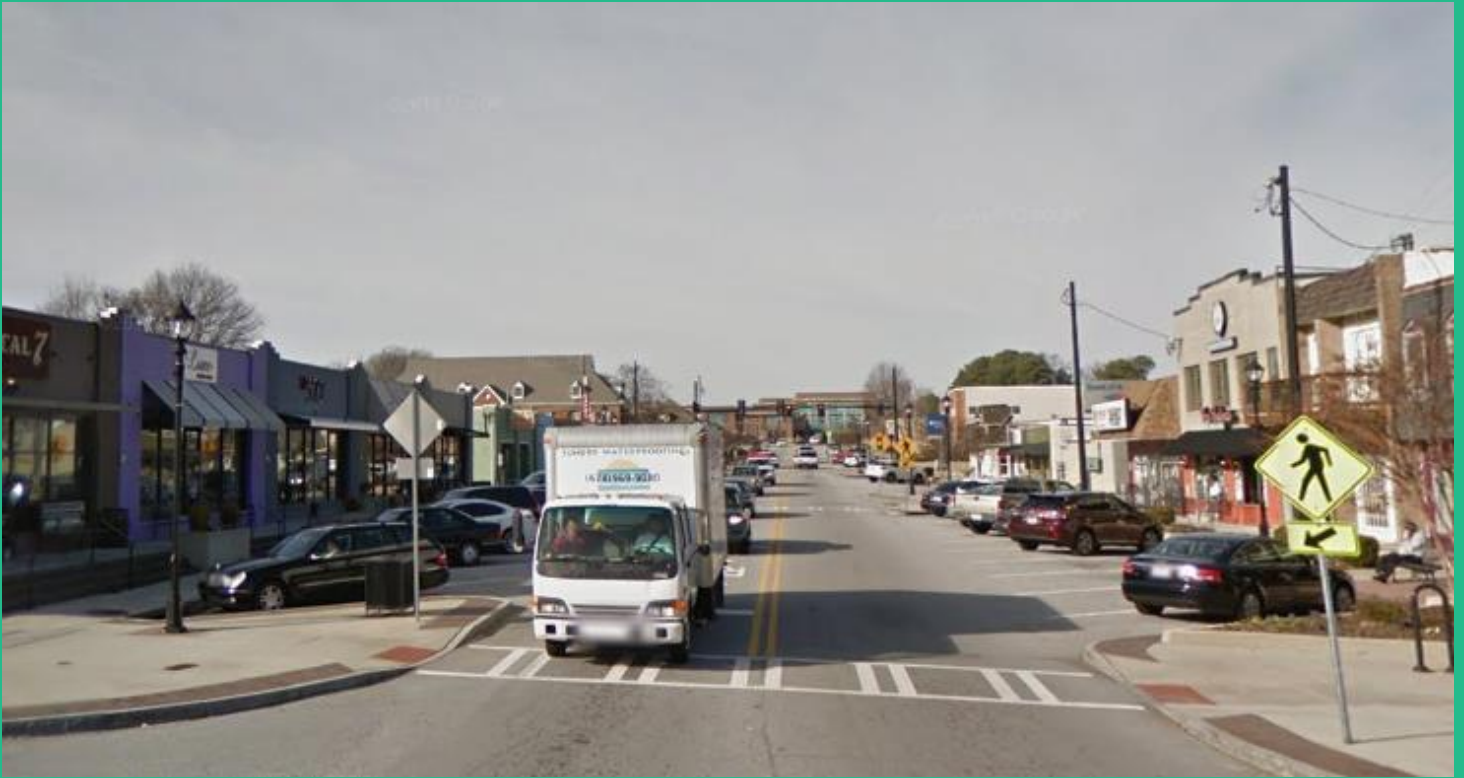
Figure 16: Existing crosswalk at Railroad Avenue looking north on Main Street (Source: Google Street View)

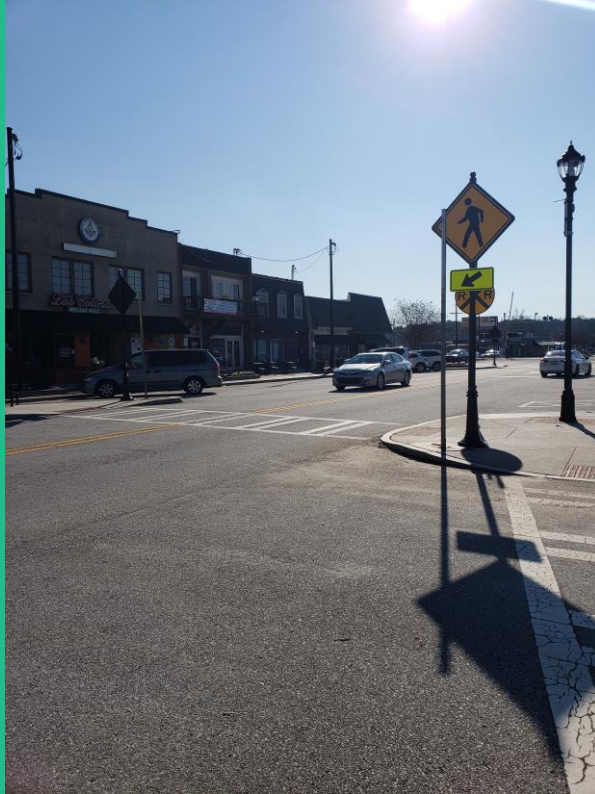
Figure 17: Crosswalk in front of Village Burger Restaurant

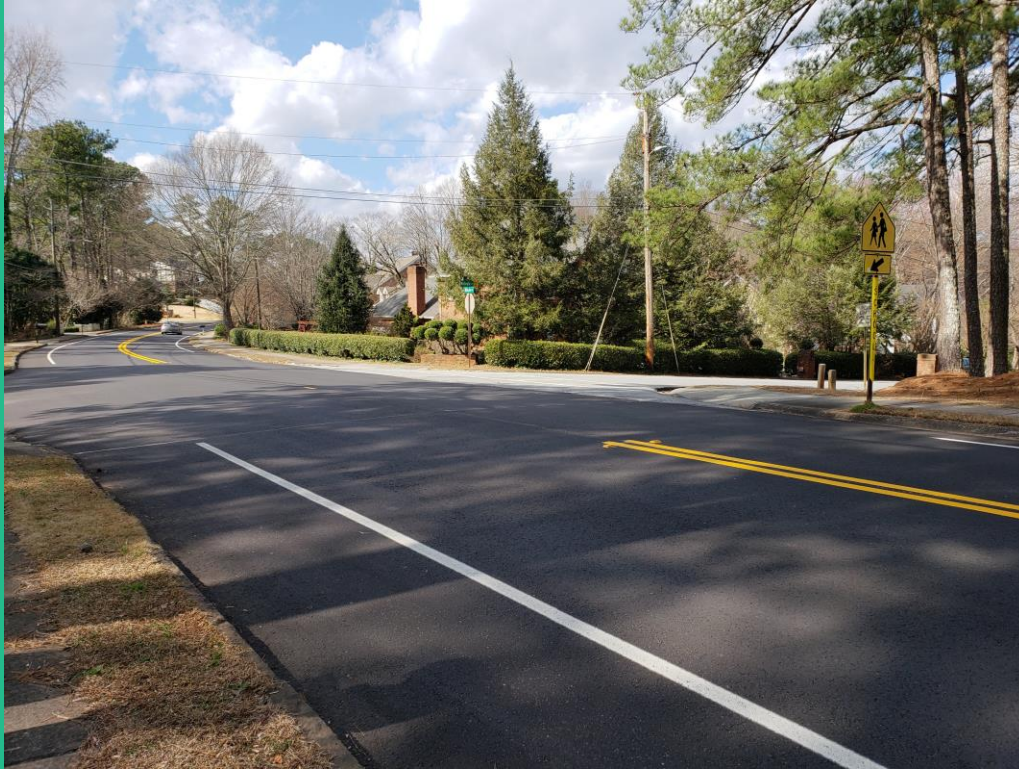
Figure 18: View of a crosswalk at the intersection with Midvale Court

- The ramps and crosswalk at Midvale Court/Crestcliff Drive need to be updated and/or redesigned with supplemental signage.

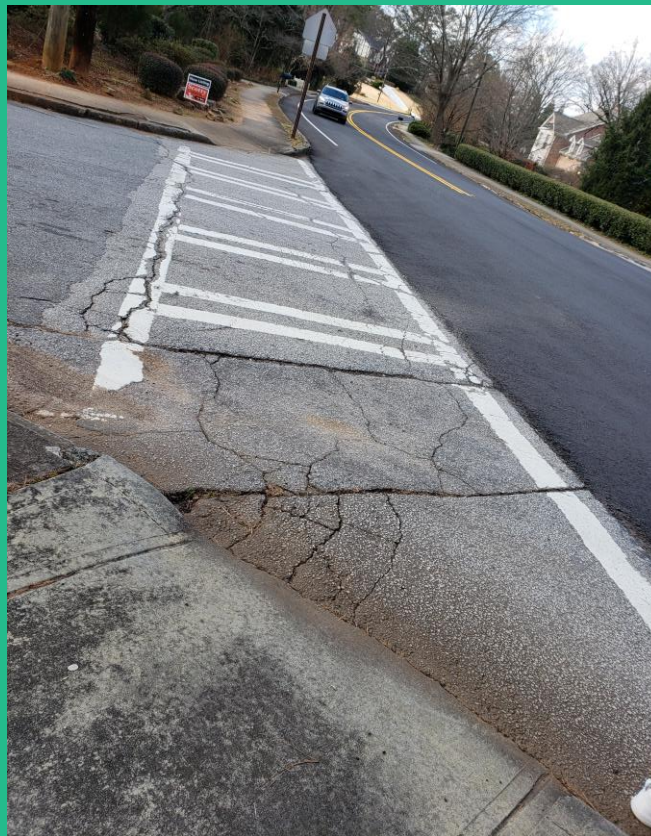
Figure 19: Damaged curb cut and pavement at intersection with Midvale Court/Crestcliff Drive
